Premium® Tooth

Aesthetic complications. A treatment protocol for fixed prostheses.

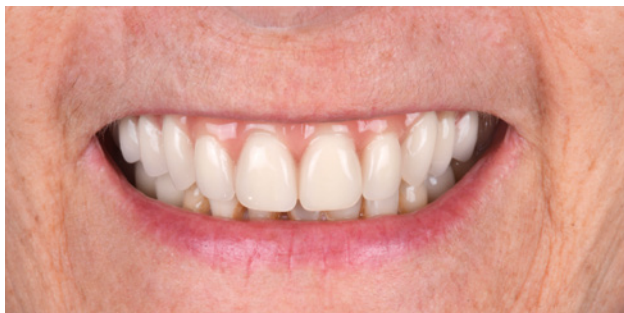
Figure 09 – Try-in of the provisional prosthesis.

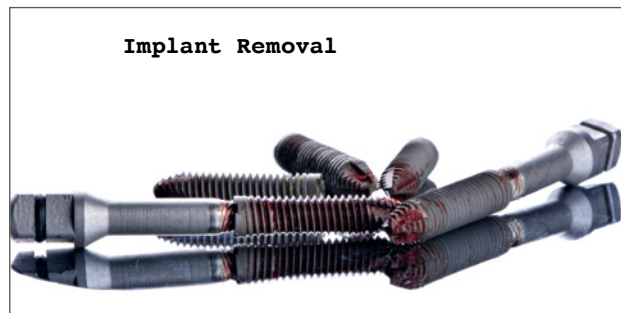
Figure 10 – Surgical phase 2 – Removal of poorly positioned implants.

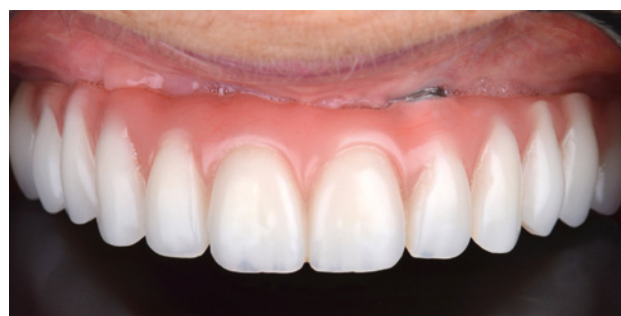
Figure 12 – The provisional prosthesis in situ.

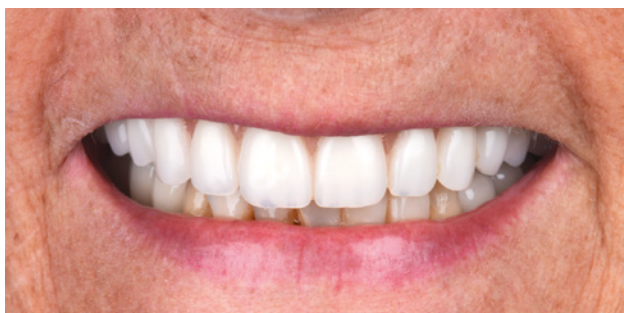
Figure 13 – Final smile.
