Topic: Composite restorations

Vishaal Shah describes how he used composite resin to replace failing and anatomically incorrect posterior restorations, resulting in an aesthetic and durable outcome

Creating anatomy for restored comfort and function

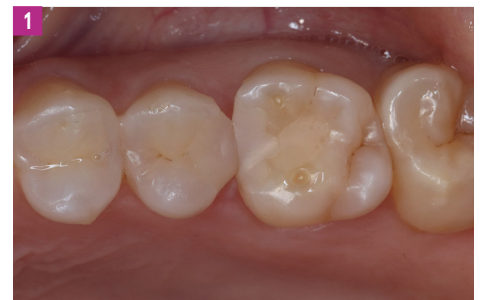
A 40-year-old female patient presented at Denticity @ Hoddesdon. She was complaining of food packing between the UR5 and UR6 and sensitivity in the UR6 area where a filling had been placed a few months previously (Figure 1).

FIGURE 1: The patient was complaining of food packing and sensitivity between the UR5 and UR6

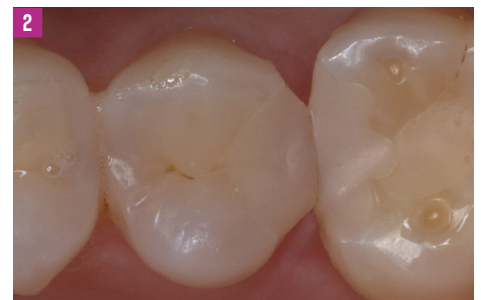
A clinical and radiographic assessment established that the UR5 had a large distal occlusal composite restoration, which was not in keeping

FIGURE 2: The UR5 had a large distal occlusal composite restoration that was overextended

with the anatomy of the tooth due to its wide emergence profile (Figure 2).

Both restorations were anatomically incorrect, as they were not in harmony with the anatomy of the patient's natural teeth and had been left completely flat occlusally. The UR5 had been overextended distally, leading to food packing.

Unsure of the previous protocols for bonding, it was decided that the most appropriate treatment option would be to remove and replace the mesial occlusal filling on the UR6 and the distal occlusal restoration on the UR5.

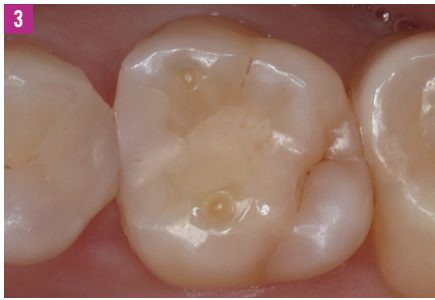
The UR6 had an older occlusal composite filling and a mesial occlusal restoration that had been placed more recently by her GDP (Figure 3). The UR6 was also showing signs of occlusal wear with enamel pitting noted on both the crests of the mesial buccal and mesial palatal cusps.

FIGURE 3: The UR6 had an existing occlusal composite filling and a recently placed mesial occlusal restoration

The patient suffered with dentine hypersensitivity with reversible pulpitis associated with potential leakage of the recent UR6 mesial occlusal restoration.

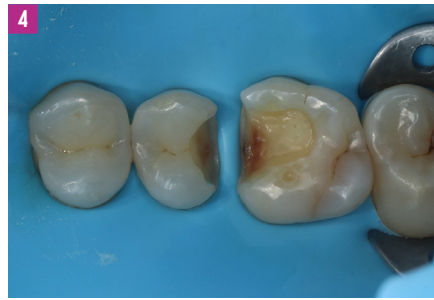
FIGURE 4: Removal of the old restorations revealed caries at the base of the UR6 mesial box and axial wall caries was also noted

Local anaesthetic was administered to the patient by buccal infiltration and rubber dam was placed. Removal of the old restorations revealed caries at the base of the UR6 mesial box, and axial wall caries was also noted (Figure 4).

The presence of caries and the lack of adequate bonding of the restoration to the affected dentine was likely to have been the reason for the sensitivity.

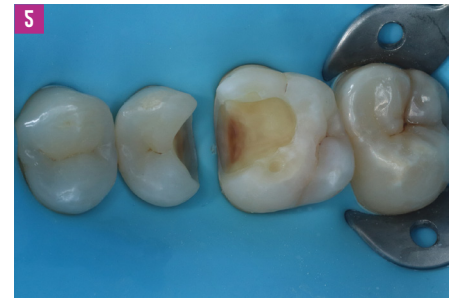
FIGURE 5: Care was taken to ensure that the entire cavity margin was clear of any carious dentine by at least 1mm

Care was taken to ensure that the entire cavity margin was clear of any carious dentine by at least 1mm from the amelodentinal junction (Figure 5). Once preparation was complete and all caries removed, the UR5 and UR6 were sandblasted with 27 micron aluminium oxide powder (Figure 6).

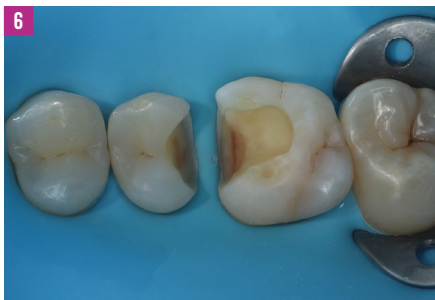
FIGURE 6: Once preparation was complete and all caries removed, the UR5 and UR6 were sandblasted with 27 micron aluminium oxide powder

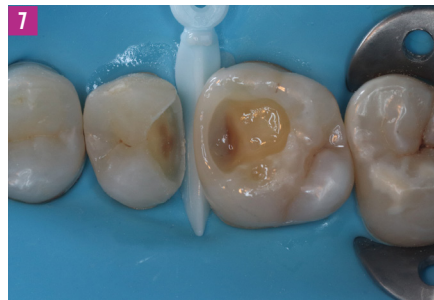
FIGURE 7: The mesial wall of the UR6 was built up using Venus Diamond Universal shade A3

The mesial wall of the UR6 was built up using Venus Diamond Universal shade A3 (Figure 7). The composite was thoroughly packed by

condensing the material with a burnisher to ensure that no voids were left, followed by a probe to remove any excess material.

The material was then smoothed with a microbrush to create the marginal ridge.

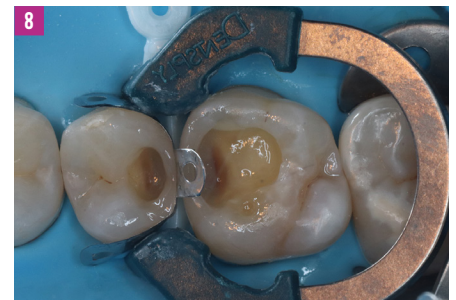
FIGURE 8: Build-up of the UR5 distal wall to the correct anatomical profile

The same procedure was repeated to build up the distal wall of the UR5 (Figure 8).

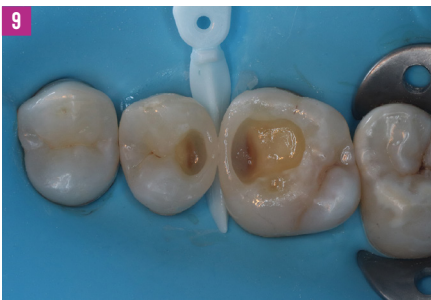
FIGURE 9: A good interproximal embrasure shape was achieved, with an anatomically correct contact point sufficiently wide to prevent food from packing in the area

Finally, a good interproximal embrasure shape was achieved, with an anatomically correct contact point sufficiently wide to prevent food from packing in the area (Figure 9).

It is important to understand that this is probably the most critical part of the restoration and time and care must be taken to get it right. If the interproximal profile is incorrect then the

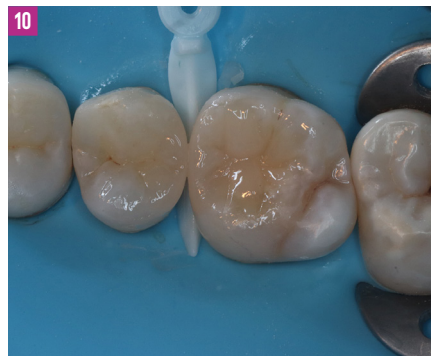
FIGURE 10: Following restoration of the interproximal surfaces, the cusps of each tooth were built up individually

Following the restoration of the interproximal surfaces, the cusps of each tooth were built up individually (Figure 10).

It is key to remember that the cusps need to be in the correct positions in relation to the central fissure line of the tooth being restored which should, in turn, be consistent with the central fissure pattern of the occlusal plane. This is why isolation of the entire quadrant is of paramount importance.

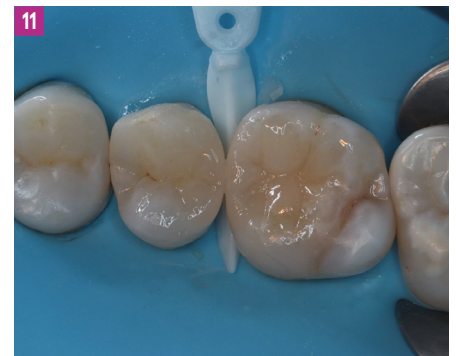
FIGURE 11: The un-restored portions of the teeth were used to mimic the depth and position of the fissure patterns

I referred to the un-restored portions of the teeth to mimic the depth and position of the fissure patterns (Figure 11).

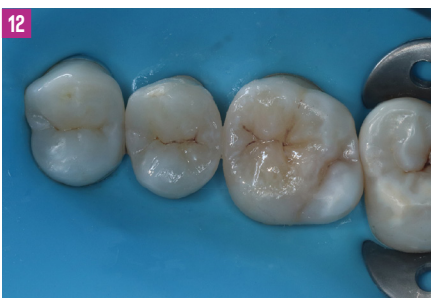
FIGURE 12: The final effect was created with a touch of colour using Kulzer Venus Color in choco and white shades

The final effect was created with a touch of colour using Kulzer Venus Color in choco and white shades (Figure 12).

Although the restoration will gradually develop a natural stain, I find that these shades stand the test of time, ageing appropriately with the natural dentition.

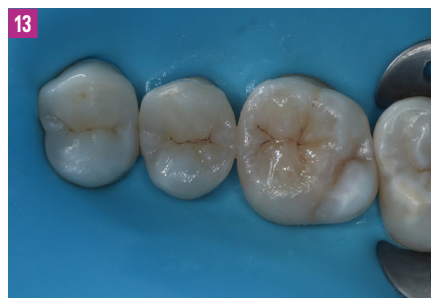
FIGURE 13: A final light-cure was carried out through glycerine gel to prevent the oxygen inhibition layer

A final light-cure was carried out through glycerine gel to prevent the oxygen inhibition layer (Figure 13). The restorations were carefully examined for any irregularities or excess composite and the rubber dam was then removed (Figure 14).

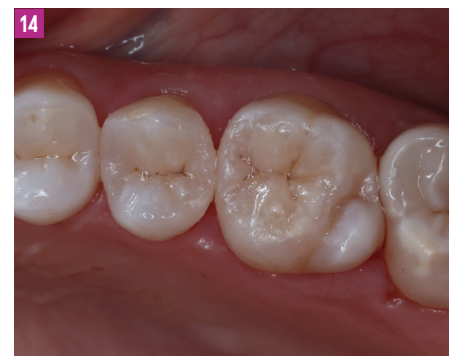
FIGURE 14: The rubber dam was removed

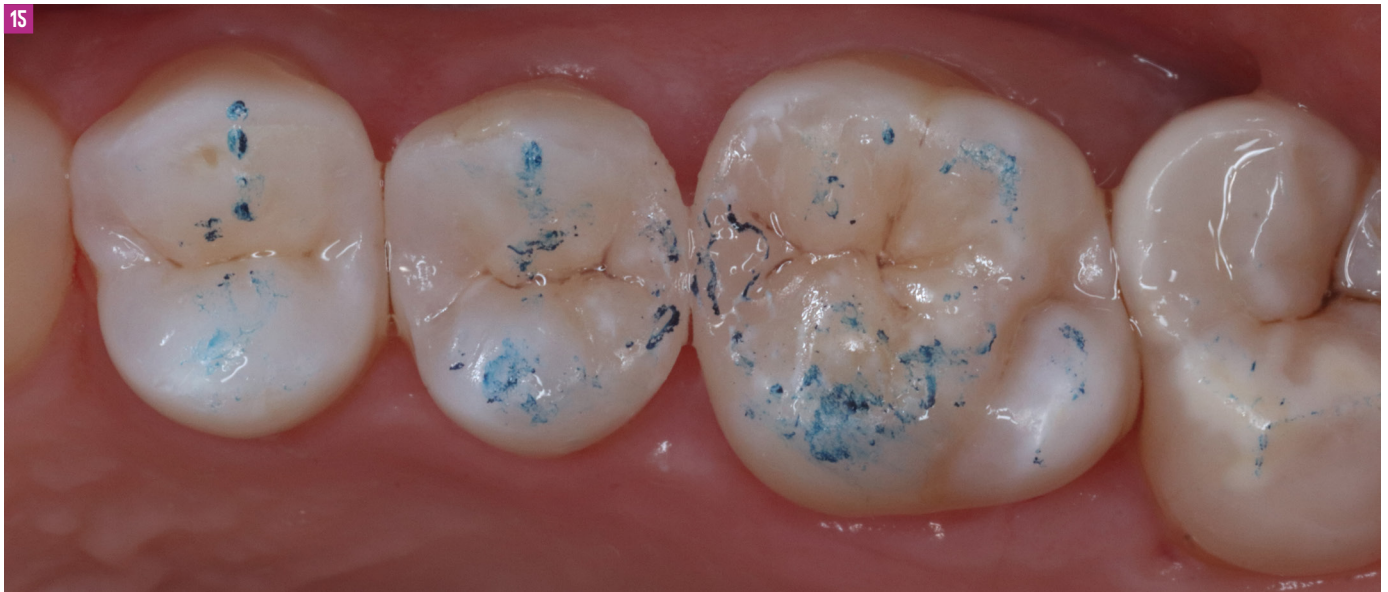
FIGURE 15: The occlusion was checked in maximum intercuspation position as well as in protrusive and excursive movements

It is important that adjustments are made incrementally to ensure that contacts are not fully removed and the anatomy of the restoration is maintained

The occlusion was checked in maximum intercuspation position as well as in protrusive and excursive movements (Figure 15). Minimal adjustments were made using ultra-fine composite finishing burs. The occlusion was checked again and further reduction carried out.

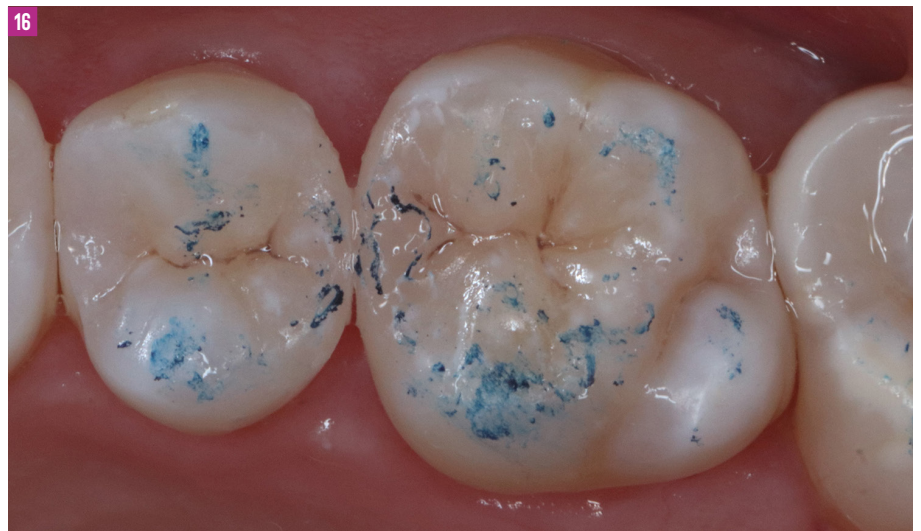
FIGURE 16: The patient was delighted with the natural-looking restoration and no longer experiences any symptoms or sensitivity

An aesthetic, functional and durable outcome was achieved. Creating the shapes of both teeth was difficult initially and the main challenge was the build-up of the proximal walls. The patient was delighted with how the restorations adapted to the surrounding dentition and she no longer experiences any symptoms or sensitivity (Figure 16). [CD](#)
