Simple restoration creates illusion of depth

Elaine Mo describes restoring a carious molar with durable composite resin, overcoming the challenge of naturally deep fissures

Elaine Mo

Associate dentist,
Square Mile Dental Centre

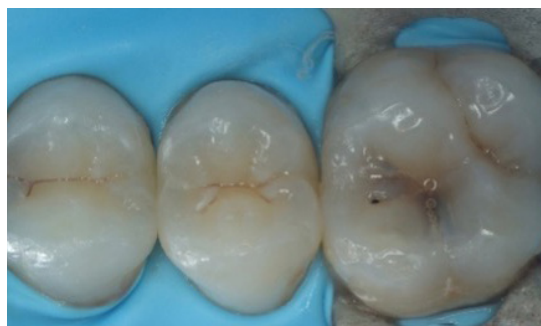
Occlusal caries was noted on the UL6 and LL6 (Figures 1 and 2) with shadowing visible when the teeth were wet and dry, suggesting caries in the dentine level (Kidd and Fejerskov, 2016).

The caries had formed within the deep natural fissures of the teeth and spread.

Figures 1 and 2: Occlusal caries was noted on the UL6 and LL6

She consented to have the caries treated and opted to restore the teeth using composite resin. The UL6 was treated first.

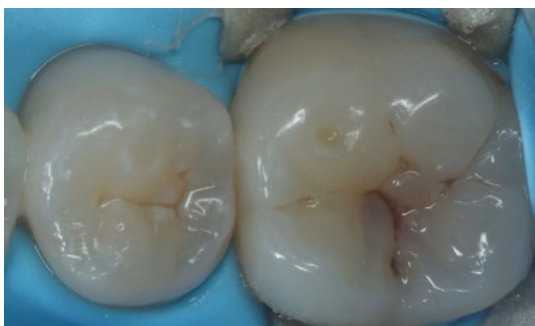
Figure 3: The caries on the UL6 was removed using an electric motor handpiece and fine red banded burs

The caries was removed using an electric motor handpiece and fine red banded burs (Figure 3). The enamel-dentine junction (EDJ) and periphery were cleared of all decay and stained tissue.

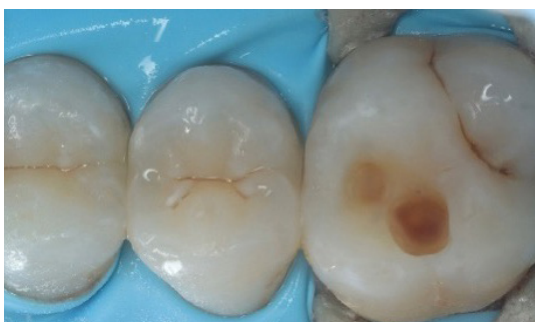
Figure 4: The enamel-dentine junction and periphery were cleared of all decay and stained tissue

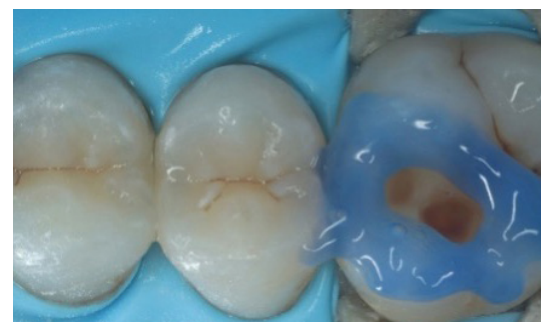
Figure 5: Selective bonding of the enamel was carried out using a viscous etch of 35% ultra-etch phosphoric acid

Following a self-etch dentine bonding protocol, selective bonding of the enamel was carried out using a viscous etch of 35% ultra-etch phosphoric acid for 30 seconds (Figure 5). The etch gel was rinsed for 30 seconds, then air dried with the three-in-one tip and high-speed suction.

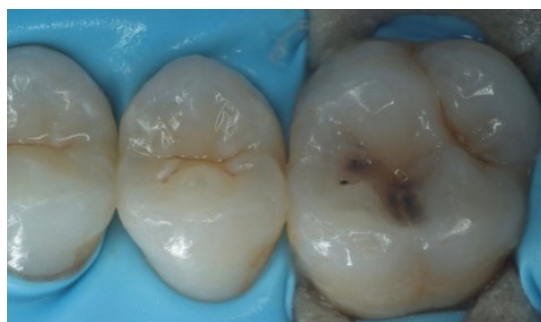
Figure 3: The caries on the UL6 was removed using an electric motor handpiece and fine red banded burs

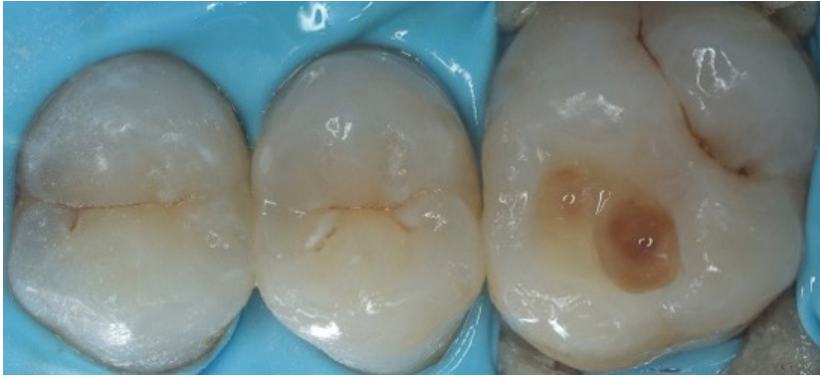
Figure 6: Kulzer Venus Diamond Flow was applied to line the cavity base and seal the dentine floor

Following bonding, a small amount of Kulzer Venus Diamond Flow was applied and light-cured. The material lines the cavity base and seals the dentine floor (Figure 6). The resin coat also helps to reduce surface tension prior to the next layer of composite.

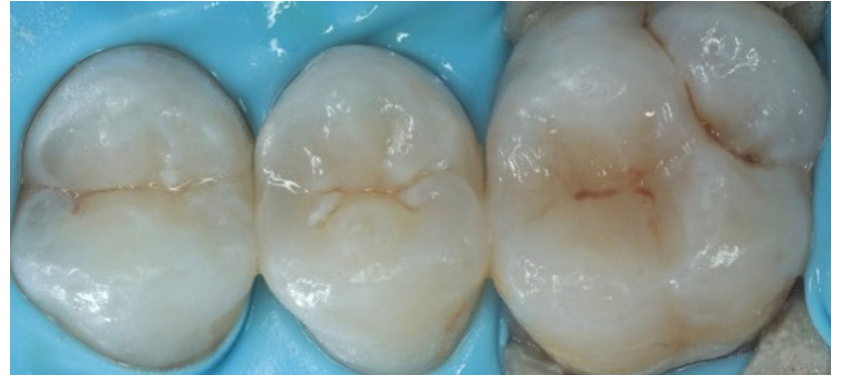
Figure 7: The UL6 was built up in light-cured increments using Kulzer Venus Diamond A2 shade

The UL6 was built up in light-cured increments using Kulzer Venus Diamond A2 shade (Figure 7). The material was packed using an ultrasonic composite instrument to reduce any voids between layers and allow for better manipulation of the material. I enjoy the easy handling of Venus Diamond, as it is not sticky and does not slump. ▶

The restoration was built up mainly with primary anatomy. This was to avoid creating deep fissures that can cause the patient to feel like food has become stuck. This was the area where the caries initially formed.

Instead, we can aesthetically create the illusion of depth by adding a small amount of stain. This is especially beneficial if, as in this case, the patient presented with naturally stained fissures.

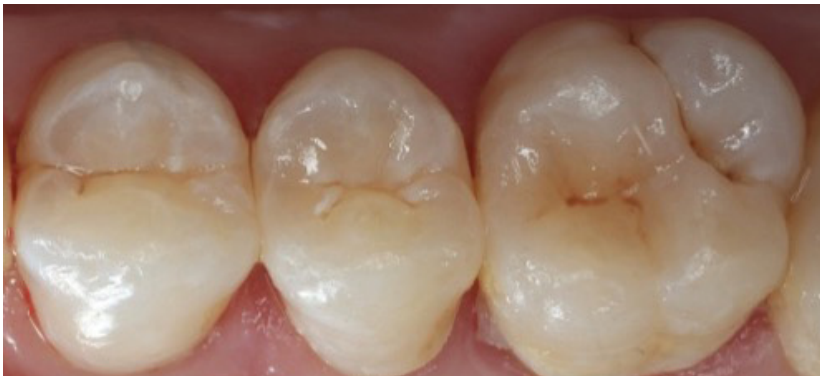
Figure 8: Rubber dam was removed, and minimal polishing was completed using brown and green mini polishing points

Rubber dam was removed, and minimal polishing was completed using brown and green mini polishing points (Figure 8) at a low-speed on the electric handpiece with water. This process polishes the composite surface. A polishing brush on a slow speed was used for a final lustre.

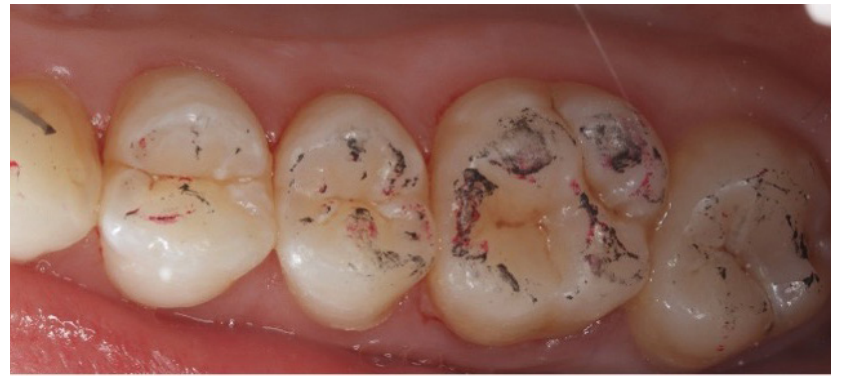
Figure 9: The occlusion was checked with 21 micron Accufilm articulating paper in all lateral and dynamic movements

The occlusion was checked with 21µ Accufilm articulating paper in all lateral and dynamic movements (Figure 9).

No adjustments were required. The same restorative and polishing protocols were used to restore the LL6 (Figure 10).

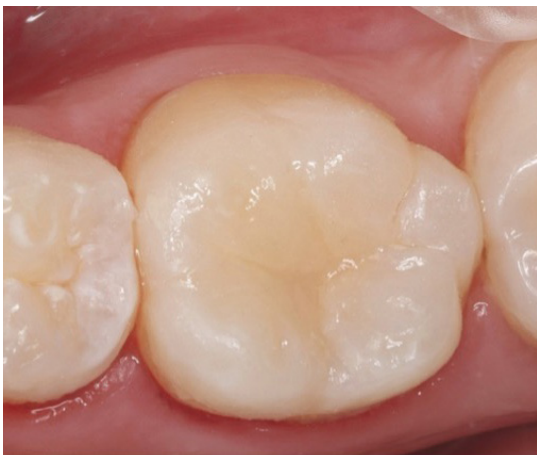
Figure 10: The same restorative and polishing protocol was used to restore the LL6

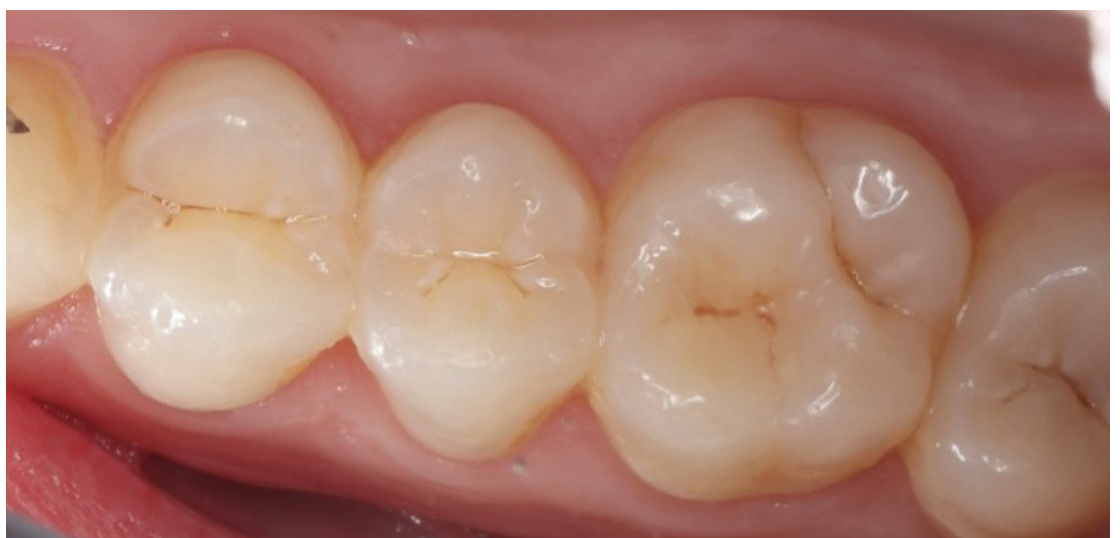
Figure 11: The patient was very happy with the natural-looking result and reported that all was satisfactory at the two-month review

A successful functional and aesthetic outcome was achieved. The caries had originally developed in the patient's natural deep fissures and had spread. In this case, I believe that by keeping the restoration simple, creating only primary anatomy and avoiding replication of the original fissure patterns and pits, food traps can be prevented.

The patient was very happy with the natural-looking result and reported that all was satisfactory at the two-month review (Figure 11). **D**
