Restoration case: a perfect smile for the bride

David Smith describes restoring a smile with multiple veneers and a single dentine-bonded crown

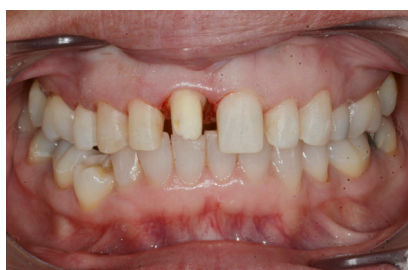
Figure 2: Significant gingival recession had occurred, exposing the margins of the veneers that were also stained

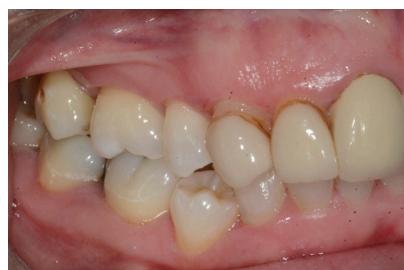
Figure 4: Lateral view - right side

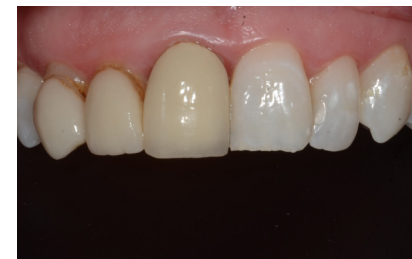
Figure 3: The UR1 had a porcelain-bonded crown that did not match the surrounding teeth

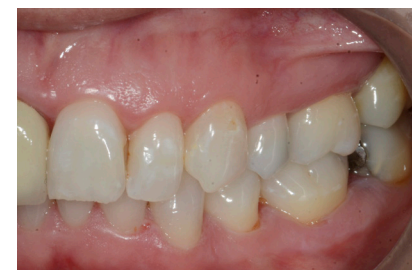
Figure 5: Lateral view - left side

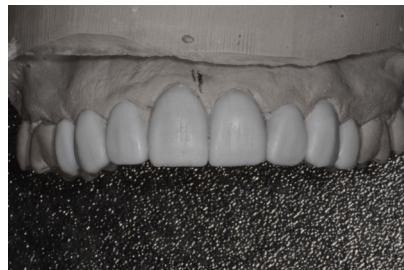
Figure 7: A diagnostic wax-up was fabricated to visualise the proposed changes

At the next appointment, the patient was provided with basic periodontal treatment, oral hygiene instruction and diet advice. She was given trays and 16% carbamide peroxide to whiten her upper and lower teeth at home. A diagnostic wax-up was fabricated to visualise the proposed changes. A transparent polyethylene stent was constructed on a stone replica model of the wax-up.

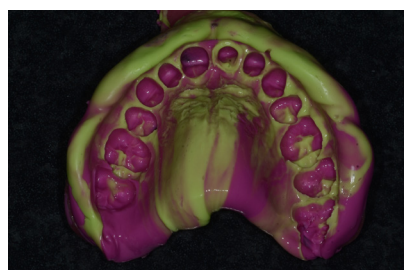
Figure 10: Flexitime impression material was chosen due to its outstanding precision and highly accurate detail reproduction

An impression was taken in a special tray using Heraeus Kulzer Flexitime Monophase and Medium Flow. Flexitime impression material was chosen due to its outstanding precision and highly accurate detail reproduction. The Monophase was mixed automatically in the Dynamix Speed dispenser, creating a homogenous material. This was used in conjunction with the Medium Flow 'wash', to create a void-free impression. The process was well

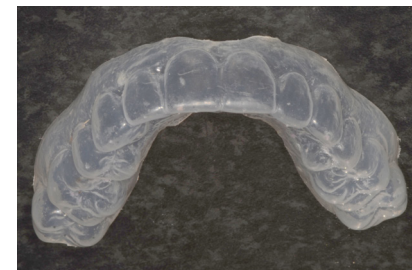
Figure 8: A transparent polyethylene stent was constructed on a stone replica model of the wax-up

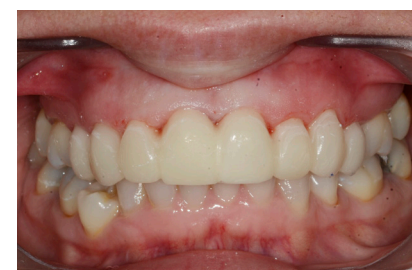
Figure 11: Temporary restorations were fabricated using the stent, allowing the patient to assess the proposed final outcome for a second time

Temporaries were fabricated using the stent, allowing the patient to assess the proposed final outcome for a second time. The temporaries were then removed. The veneers and crown were tried in, individually at first, to check the marginal fit, then together to see their overall integration with each other. A sectional rubber dam is often used for isolation, but in this case moisture control was adequately achieved using retraction and cotton wool rolls.
