# Natural upper anterior transformation

**Vishaal Shah** describes how he uses the biologically oriented preparation technique and direct composite restoration to repair a patient's damaged central incisors

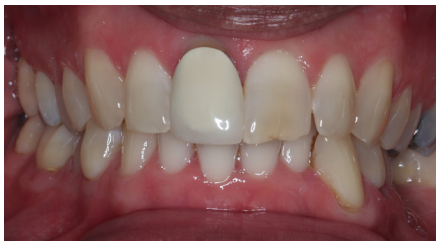
His main concern was his UR1 crown (Figure 1), which had a receding gum line and poor aesthetics. The patient's UL1 was chipped with a fracture extending down the buccal midline of the tooth (Figure 2). He also wanted whiter and straighter teeth but was reluctant to invest in orthodontic treatment.

**FIGURE 1:** The patient wanted improved aesthetics for his UR1 crown

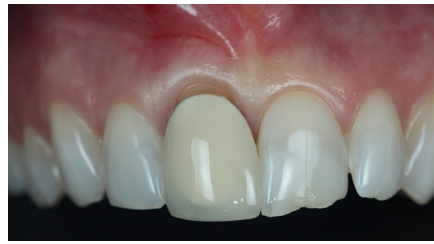
**FIGURE 2:** The UL1 was chipped with a fracture extending down the midline of the tooth

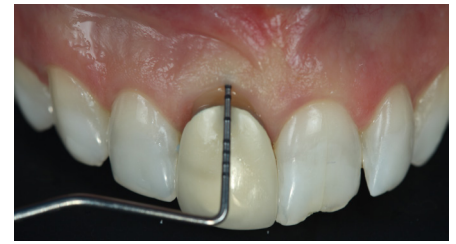
**FIGURE 3:** The depth of the gingival sulcus was assessed

preoperative impression was taken using super soft putty. Local anaesthetic was administered, and the depth of the gingival sulcus assessed (Figure 3). The old crown was removed, and the underlying tooth core examined (Figure 4). The angle of the core was checked in three dimensions within the line of the arch.

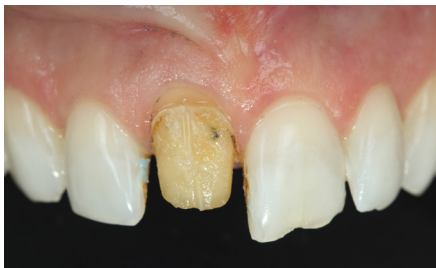
**FIGURE 4:** The underlying tooth core was examined

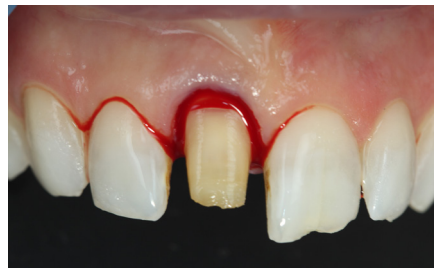
**FIGURE 5:** The tooth was prepared using the biologically oriented preparation technique (BOPT)

The UR1 was prepared using the biologically oriented preparation technique (BOPT) (Figure 5). The treatment stages and intended outcome of the BOPT technique were fully explained to the patient.

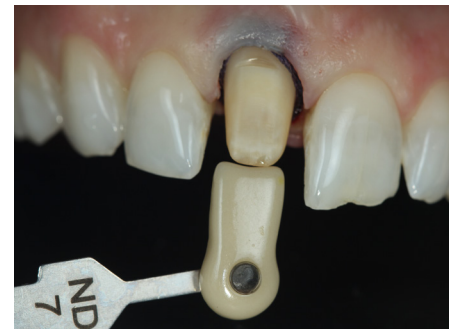
**FIGURE 6:** A stump shade was taken

Retraction cord soaked in astringent was applied into the gingival sulcus to stem the bleeding and to retract the gingival tissues. A stump shade was then taken (Figure 6) that would later be communicated with the laboratory. A bis-acryl resin material was extruded into the preoperative impression and

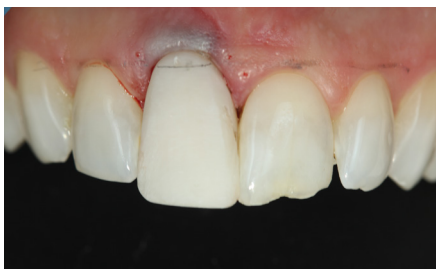
**FIGURE 7:** The temporary crown was marked to indicate the ideal level for the cervical portion of the crown

The tooth was marked to indicate the ideal level for the cervical portion of the crown (Figure 7). The gingival profile was drawn onto the temporary crown and the crown adjusted accordingly (Figure 8). The final primary anatomical features and shapes were pencilled onto the crown (Figure 9) and created using a range of composite finishing burs and Kulzer Venus Supra pre and high gloss finishers.

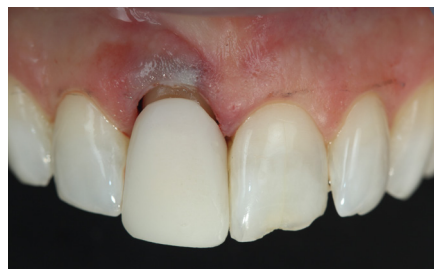
**FIGURE 8:** The gingival profile was drawn onto the temporary crown and the crown adjusted accordingly

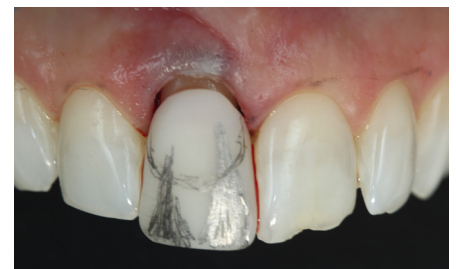
**FIGURE 9:** The final primary anatomical features and shapes were pencilled onto the temporary crown

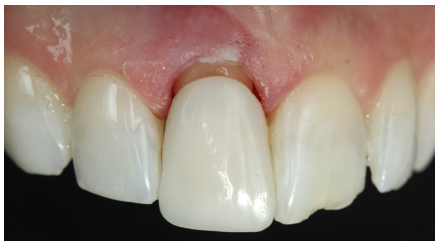
**FIGURE 10:** The temporary crown, placed immediately postop, was left in situ for four weeks

The temporary crown was in place for four weeks (Figure 10). The fact that this was a well-fabricated and aesthetically pleasing temporary crown made the length of time and the additional visits required to complete the restoration more acceptable to the patient.

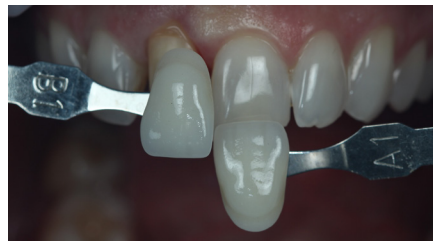
**FIGURE 11:** The temporary crown was removed and shade B1 was recorded

The temporary crown was removed under local anaesthetic and the overall basic shade B1 was recorded (Figure 11). The stump shade was rechecked to ensure that it was the same as when initially taken.

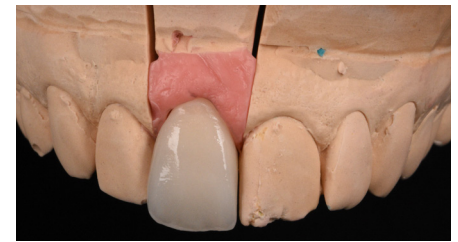
**FIGURE 12:** The laboratory fabricated the final crown

The lab fabricated the final crown based on the photos, impressions and lab prescription (Figure 12). In this case, I requested that the UR1 crown be made and then the model digitally

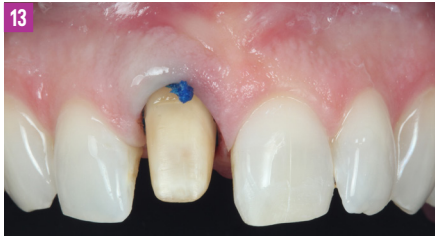
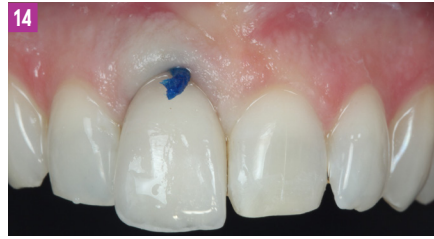
**FIGURES 13 and 14:** A retraction cord was placed into the gingival sulcus and the UL1 prepared for composite restoration

The crown was placed over the tooth and ease of seating and marginal fit was assessed (Figures 13 and 14).

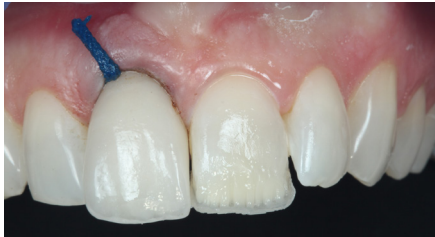
**FIGURE 16:** Venus Diamond shade Clear (CL) was placed onto the stent and Opaque Medium Chromatic (OMC) masked the transition line

Venus Diamond incisal shade Clear (CL) was placed onto the stent and extended just past the line engraved with a probe showing the palatal extremity of the prepared tooth and cured for 20 seconds. The stent was then removed very gently and the thickness of the composite palatal shell was assessed. Venus Diamond shade Opaque Medium Chromatic (OMC) was then used to mask the transition line (Figure 16).

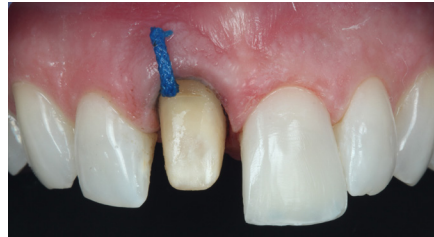
**FIGURE 17:** Venus Diamond B1 shade was used to build up the dentine layer of the tooth and proximal walls. A 0.5mm thick layer of Clear (CL) was placed over the surface

Venus Diamond B1 shade was placed to build up the dentine layer of the tooth and proximal walls. Once the dentine layer was built up, a 0.5mm thick layer of Clear (CL) was placed over the surface (Figure 17).

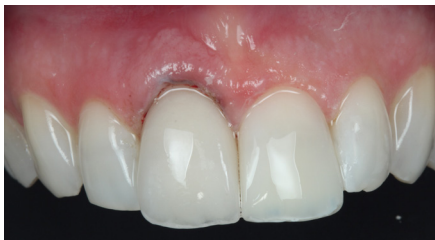
**FIGURE 19:** The crown was cemented into place with temporary cement and the retraction cord removed

The crown was cemented into place with temporary cement and the retraction cord removed (Figure 19). This was carried out as I was still not entirely happy with the position of the gingival margin in the UR1 area.

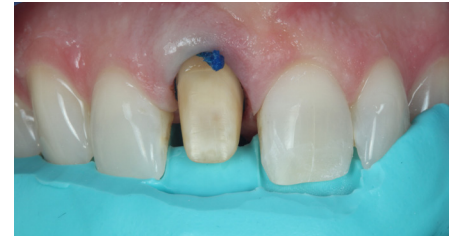
**FIGURE 15:** The putty stent was placed and the position of the crown verified

Prior to cementing the UR1 crown, a putty matrix was made using Kulzer Provil Novo. Provil Novo serves as a stable base for precise and accurate impression of a model that can be used as a stent. As the putty is green, it provides a good contrast to be able to assess thickness of the palatal shell when the clear composite is placed onto it. The putty stent was placed and the position of the crown verified (Figure 15). The palatal aspect of the UL1 was marked against the stent with a probe.

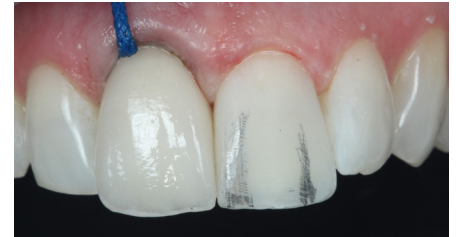
**FIGURE 18:** The pencil markings were gently smoothed out to create surface anatomy

The pencil markings were gently smoothed out to create surface anatomy (Figure 18) using the Kulzer Venus Supra polishing kit with both red and grey polishing points.
