Strong, functional and reliable restoration

Sanjay Sethi describes how he uses a layered composite approach to successfully restore a difficult-to-access deep carious lesion

Dr Sanjay Sethi BDS (Lond)

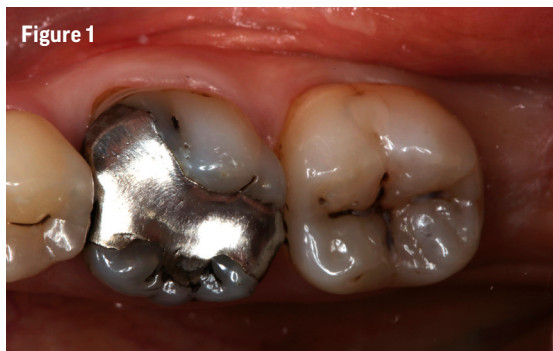
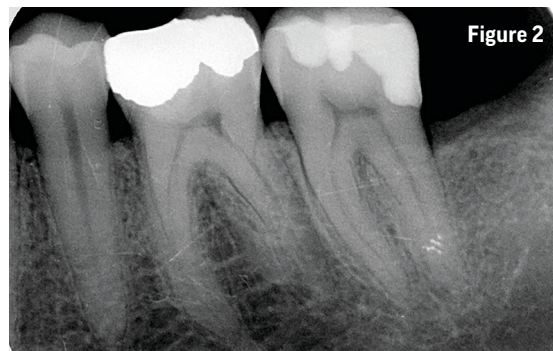
A female in her early 30s attended the Square Mile Dental Centre for caries treatment. Four months previously, the patient's mesio-angulated, impacted, lower left wisdom tooth (LL8) was extracted due to food impaction. During an appointment prior to extraction, a deep carious lesion on the distal cervical aspect of the lower left second molar (LL7) was noted on X-ray (Figures 1 and 2).

Figures 1 and 2: A deep carious lesion on the distal cervical aspect of the lower left second molar was noted on X-ray

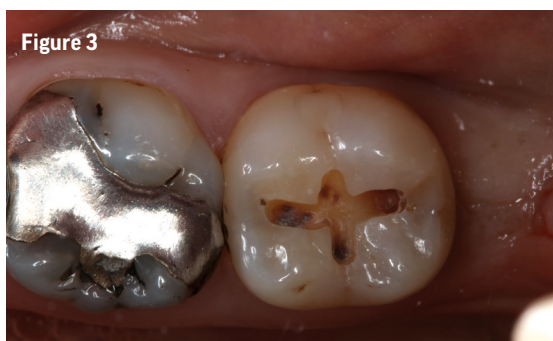
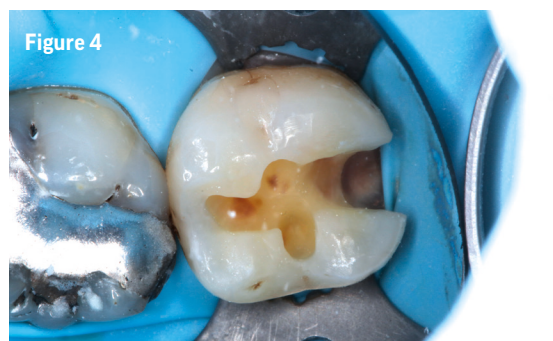
Figures 3 and 4: Cavity preparation was completed using diamond burs, finished with ultrasonic tips and light air abrasion under rubber dam

traumatising the distal gingival tissue where possible, cavity preparation was completed using diamond burs, finished with ultrasonic tips and light air abrasion under rubber dam (Figures 3 and 4). The rubber dam was tucked into the sulcus and a sectional metal matrix ivory band was chosen, which facilitated a deep marginal seal of the cavity.

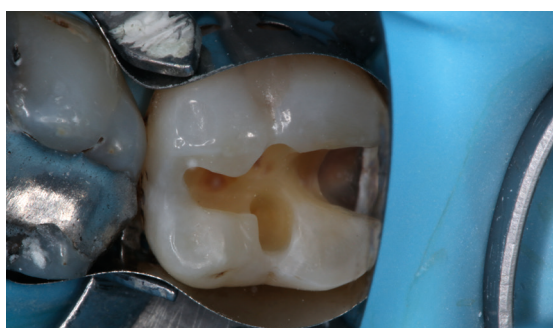
Figure 5: PTFE tape was packed between the matrix band and the cavity margin to prevent any seepage or placement of the composite apical to the cavity margin

However, due to the depth of the distal box, it was difficult to obtain a tight seal with the cavity box distal margin. Therefore, polytetrafluoroethylene (PTFE) tape was packed between the matrix band and the cavity margin to prevent any seepage or placement of the composite apical to the cavity margin (Figure 5).

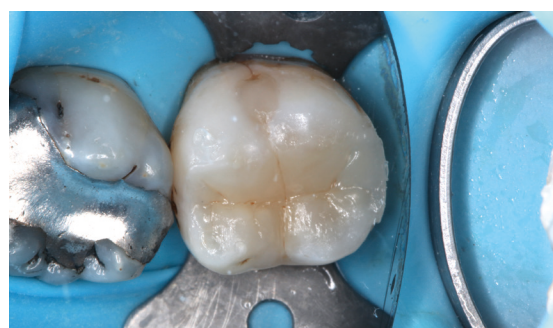
Figure 6: Venus Diamond composite A2 and Clear shades were placed, with a layered approach, in no more than 2mm increments

Venus Diamond composite A2 and Clear (CL) shades were placed, with a layered approach, in no more than 2mm increments (Figure 6). The initial distal wall was built up with CL and set to convert the cavity from a class II to a class I configuration. Each layer was light cured for 20 seconds, and deeper increments for 40 seconds in accordance with the manufacturer's instructions.

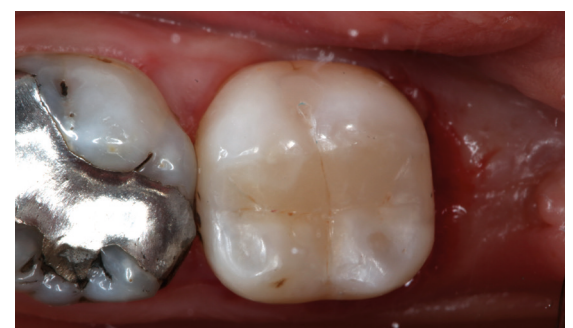
Figure 7: The low volumetric shrinkage and low shrinkage stress of the composite provided a reliable seal

A successful and functional outcome was achieved in this case. The low volumetric shrinkage and low shrinkage stress of the composite provided a reliable seal (Figure 7), especially for such a deep restoration. The patient was delighted with the result, particularly as she was aware the tooth was treated under challenging circumstances. **D**
