# Demonstrating a decade of reliability

**Hitesh Gohil** describes treating a patient with missing upper lateral incisors, with composite edge-bonding that has remained stable for almost 10 years

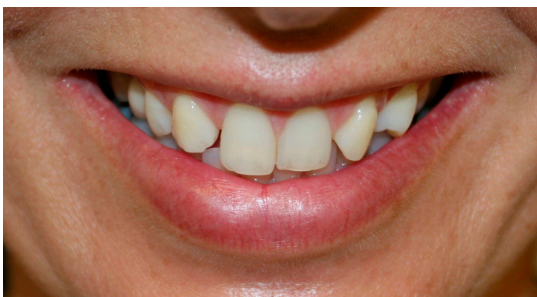
A lady in her mid-to-late 40s came to see me because she was not happy with the appearance of her upper dentition. The upper lateral incisors were missing due to a congenital condition (Figure 1).

**Figure 1:** The patient's upper lateral incisors were missing due to a congenital condition

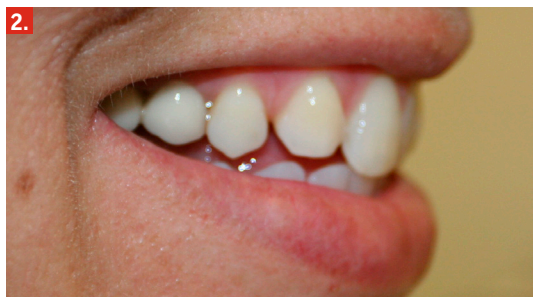
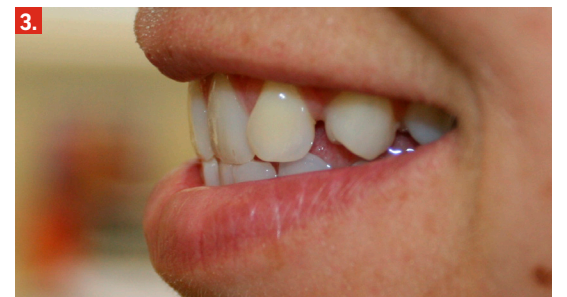
There were several challenges to overcome with the agreed plan. The width of the canines would be difficult to disguise. The blending of the premolars to resemble canines would also be problematic (Figures 2 and 3).

**Figures 2 and 3:** The width of the canines would be difficult to disguise and the blending of the premolars to resemble canines would also be problematic

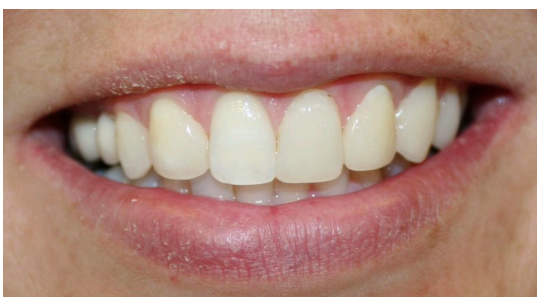
**Figure 4:** Composite edge-bonding was carried out tooth by tooth using Kulzer Venus Pearl A2 shade

Composite edge-bonding was carried out, tooth by tooth, with Kulzer Venus Pearl A2 shade (Figure 4). The composite's durability is something I have come to depend upon. I also find it very easy to handle, whether for multi-layer or single-layer placement. Venus Pearl

Using the patient's upper right central incisor as a guide, the UR3, UR4, UL1, UL3 and UL4 were restored. The edge-bonding proceeded freehand, with small, incremental layers to gradually bring the teeth into alignment. The final layer of composite was placed in one piece and carefully blended towards the tooth margins. It was then light-cured through glycerine to prevent the oxygen inhibition layer.

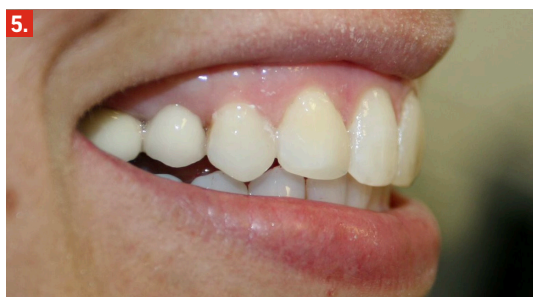
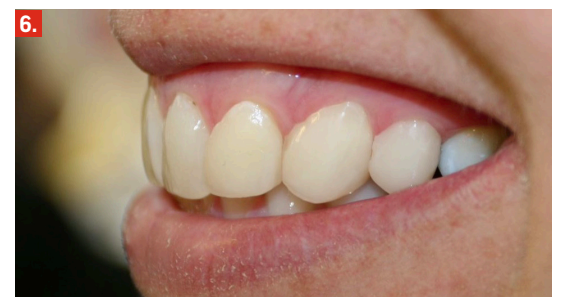
**Figures 5 and 6:** The patient was overjoyed when the result was revealed

The patient was overjoyed when I revealed the result to her (Figures 5 and 6). She had convinced herself that the treatment would only be a halfway house but she ended up with a complete, natural-looking transformation and was genuinely overwhelmed.

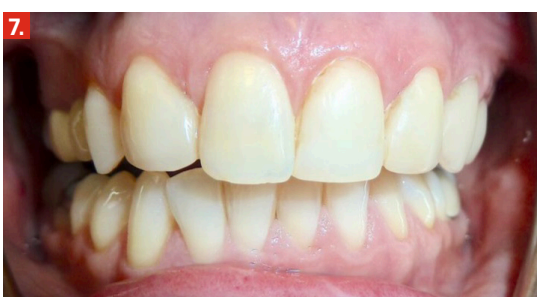
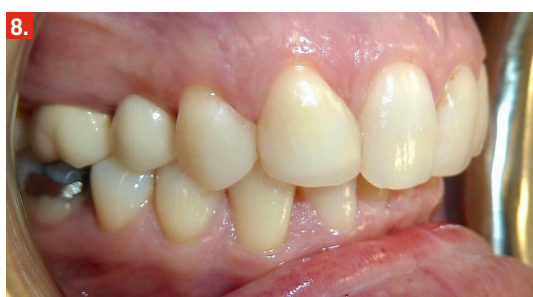
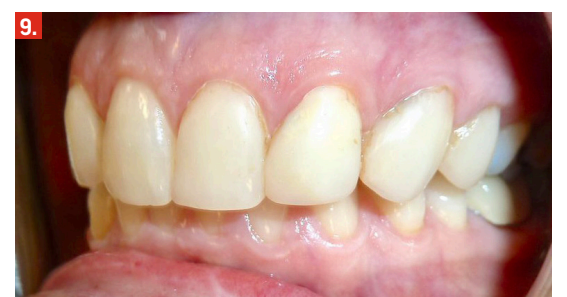
The lady has continued to attend the practice for regular reviews. Apart from very minor staining that I usually polish out, there has been no evidence of chipping after almost 10 years (Figures 7 to 9). **D**

**Figures 7-9:** There has been no evidence of chipping after almost 10 years
