# Marginal adaptation optimises aesthetics

**Rachel Derby** presents a case in which a patient with caries and tooth surface loss was treated with a material that blends seamlessly with the surrounding natural tooth for optimal aesthetic impact

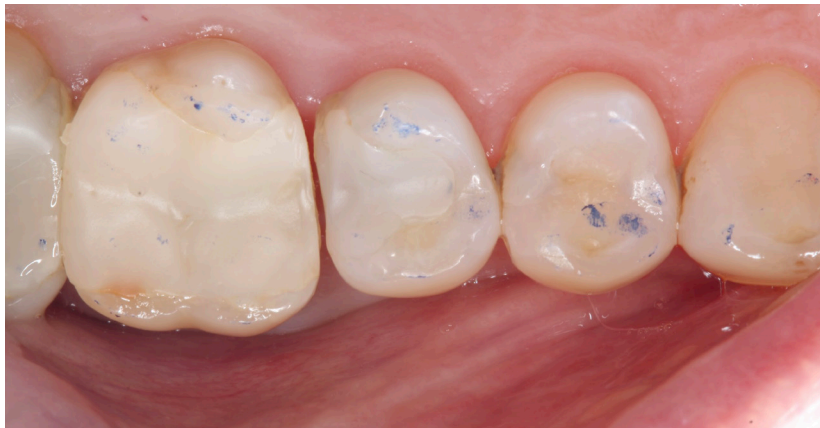
**Figure 1:** The patient had caries in the UR4 and UR5 and the UR6 responded positively to endo-frost testing

which had resulted in caries. Caries was also noted on the mesial aspect of the upper right second premolar and the distal aspect of the upper right first premolar (UR5 and UR4) (Figure 1).

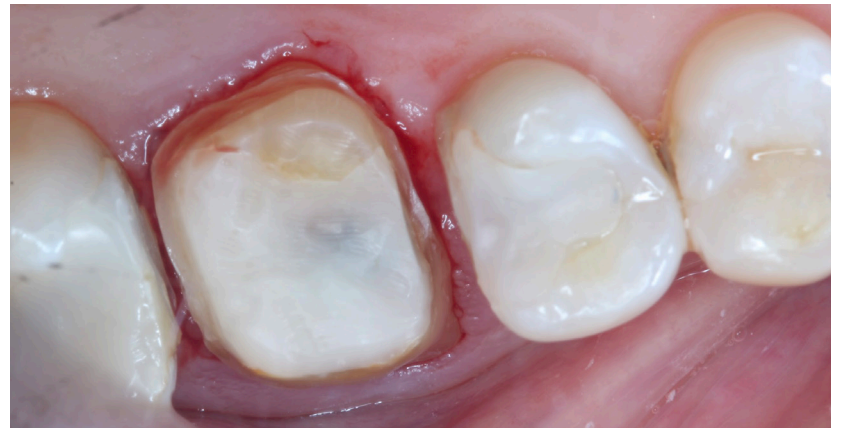
**Figure 2:** Impressions were taken for laboratory fabrication of the UR6 crown

Impressions were taken of the UR6 and sent to SJL Studios laboratory to be fabricated (Figure 2). Having previously placed the composite filling, I was confident of its integrity as a core material.

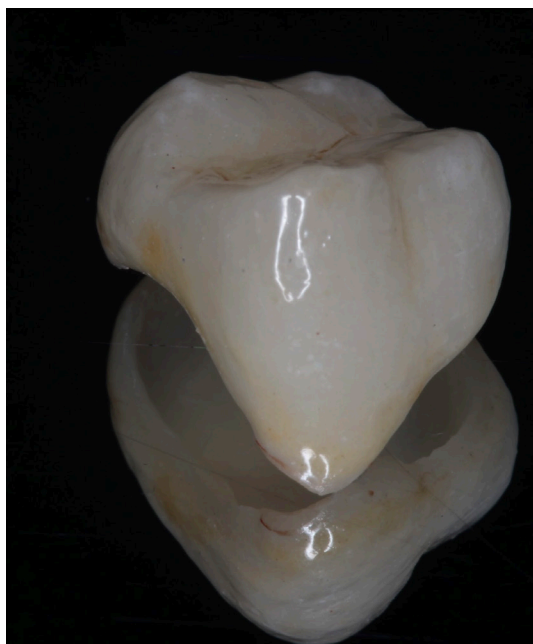
**Figure 3:** The crown was tried in and the fit and aesthetics were confirmed

At the fit appointment, the quadrant was isolated with rubber dam. The crown was tried in and the fit and aesthetics were confirmed (Figure 3). The caries was removed from the UR4 and UR5 using a drill on high and low speed settings, and the cavities were prepared. The UR4, UR5 and UR6 were sandblasted with 27 microns of aluminium oxide to enhance the strength of the bond (Figure 4).

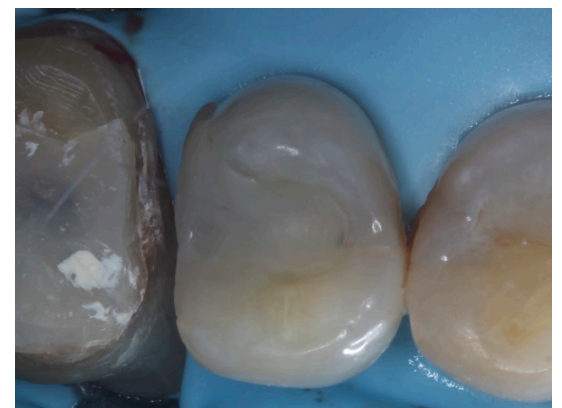
**Figure 4:** The UR6 was prepared for the crown

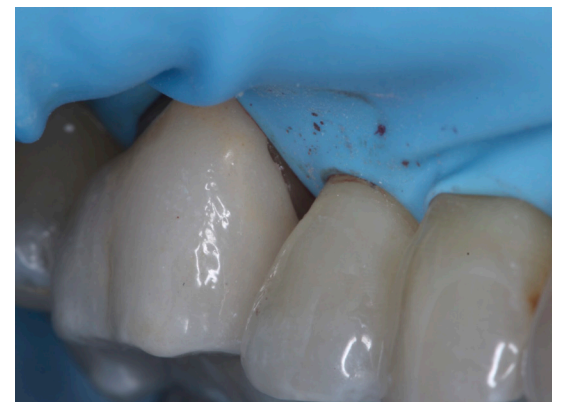
**Figure 5:** Once the crown had been fitted, the margins were cleaned

margins were cleaned with a micro brush to remove the gross material (Figure 5). Floss and Tepe brushes were used to ensure removal of cement from the interdental spaces. This would aid thorough cleaning in these areas by the patient. The restoration was then light-cured, and further removal of any excess cement was performed with a hand scaler. Once I was satisfied, the margins were polished with polishing cups.

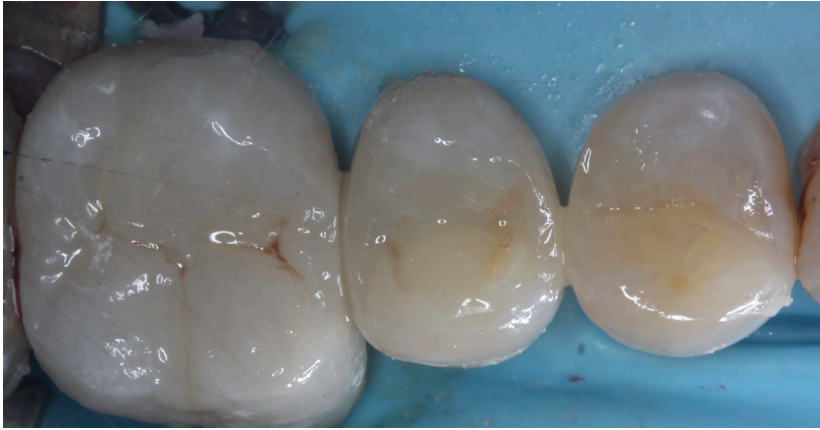
**Figure 6:** The composite restorations were carried out with Kulzer Venus Pearl One in incremental layers

Kulzer Venus Pearl One was selected for the UR4 and UR5 restorations and was applied in incremental layers (Figure 6). The aesthetic effect of the Venus Pearl One material is impressive. It was ideal for this case as the teeth were not discoloured and the cavities were minimal. The material's shade adapted well to the margins and blended seamlessly. The handling properties are superior, and consistent with other Venus materials. The rubber dam was then removed, and occlusion checked (Figure 7).

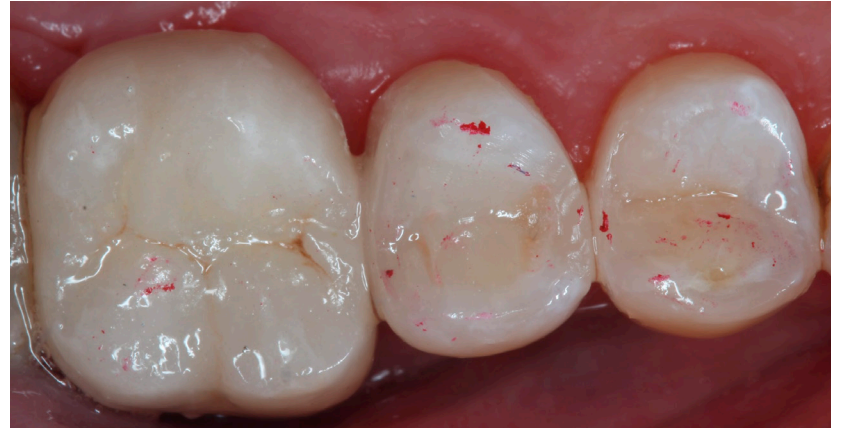
**Figure 7:** The rubber dam was removed and occlusion was checked
