Nervous teenager prefers direct restoration

James Pegg describes the replacement of a failed amalgam restoration using minimal intervention techniques

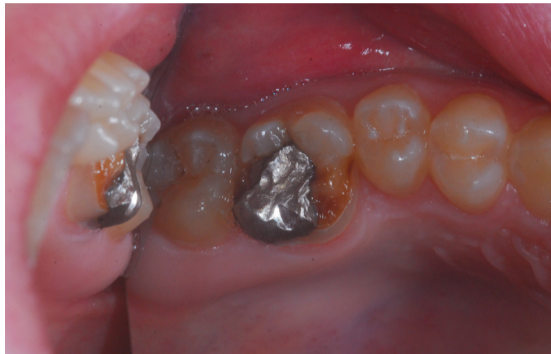
Figure 1: Examination revealed that a large amalgam restoration in the upper left first molar had fractured

A 15-year-old girl presented for an initial consultation, complaining that a filling in her back tooth had broken. She was not experiencing any pain, although she was finding the tooth rough and uncomfortable against her tongue. Examination revealed that a large amalgam restoration in the upper left first molar had fractured (Figure 1).

My recommendation to the patient was that the remainder of the failed filling should be removed. Once the quality of the underlying tooth structure had been assessed, a decision on how to restore the tooth could be made. The patient and her guardian agreed to this proposal.

At the treatment session, the remainder of the failed amalgam was removed under local anaesthesia. The underlying tooth structure was explored using Examvision 3.5x magnifying loupes. It was noted that at the margins of the cavity there was a continuous 'rim' of supragingival enamel. Some of this was stained, but none appeared carious. The dentine was similarly stained but no soft or carious tissue was seen (Figure 2). This was determined by gentle exploration, drawing the tip of a sharp probe across the surface.

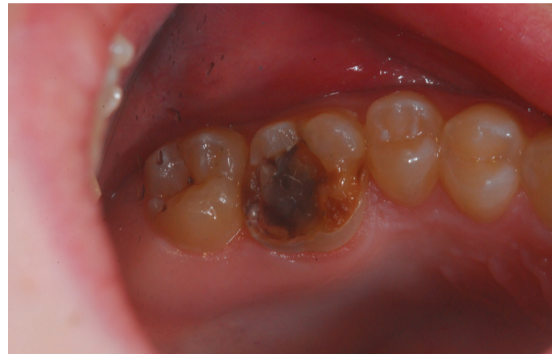
Figure 2: At the margins of the cavity there was a continuous 'rim' of supragingival enamel

Rubber dam was applied to isolate the tooth. The enamel margins at 26 were minimally prepared with an NSK air scaler with a diamond tip. The enamel and dentine surfaces were cleaned with an NSK Flash pearl powder/water slurry using an NSK Prophy-Mate neo air polisher.

A Trident matrix system was applied to the tooth mesially and distally. After etching the enamel for 60 seconds and the dentine for 20 seconds, Ibond Total Etch was coated on to the tooth with a microbrush and light-cured.

Successive increments of Venus Pearl were added to the tooth, using the compule delivery system. Each increment was sculpted into place and light-cured.

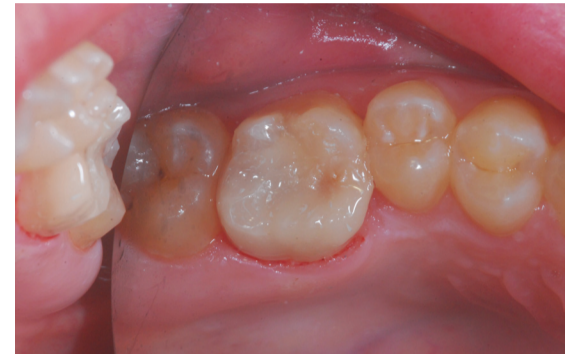
Figure 3: The patient was highly satisfied with the tooth-coloured restoration

Cases like this, with heavy amalgam staining, tend to be quite difficult to mask out. Venus Pearl performs this task exceptionally well. If I were to be self-critical of this case, I could have chosen a slightly darker dentine shade to perfectly match the surrounding tooth colour. However, the patient was highly satisfied with the end result and having a tooth-coloured restoration (Figure 3). She was not only pleased with the aesthetics but also with the minimally invasive process. **□**

After removing the rubber dam the occlusion was checked and adjusted. The restoration was given a final polish with the Venus Supra polishing kit.
