Minimally invasive, functional restoration

Nadeem Younis presents a case study for the management of anterior tooth wear using composite resin

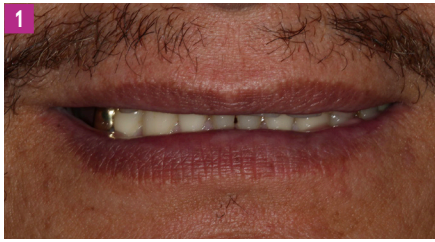
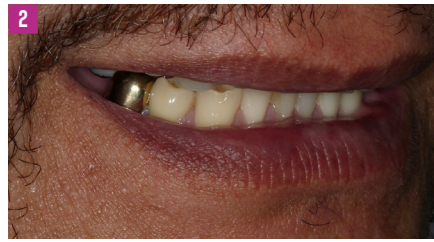
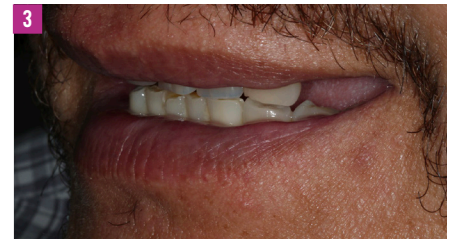
A 47-year-old male presented to Bridge Dental Practice in Burnley because he was unhappy with the appearance of his upper and lower anterior teeth (Figures 1 to 3).

FIGURES 1, 2 and 3: The patient was unhappy with the appearance of his upper and lower anterior teeth

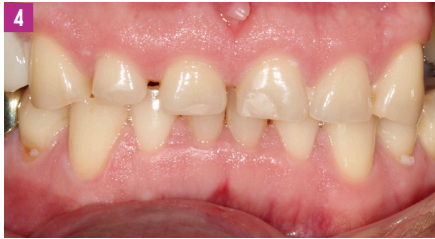
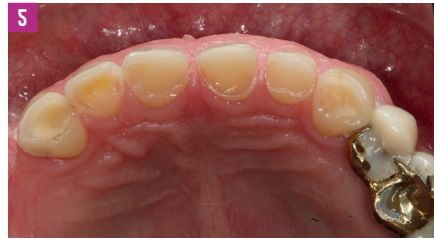
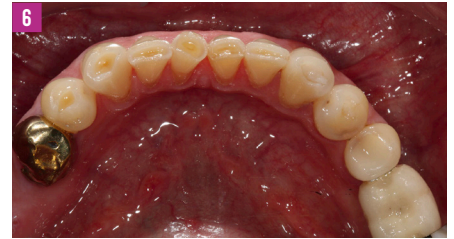
A clinical examination revealed severe tooth wear of the upper and lower anterior teeth extending into the dentine (Figures 4 to 6).

The wear was due to a combination of bruxism and dietary habits.

Reduced clinical crown heights of the upper and lower anterior dentition was noted, with secondary compensatory over-eruption of the lower incisors.

FIGURES 4, 5 and 6: A clinical examination revealed severe tooth wear extending into the dentine

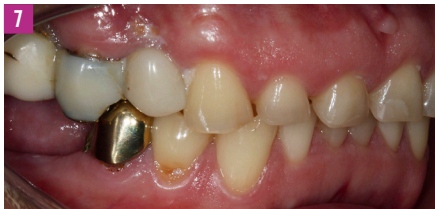
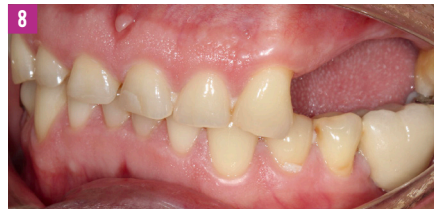
A lack of posterior support – due to missing molars on the lower right quadrant, the upper left premolars and upper left first molar – had exacerbated the anterior tooth wear (Figures 7 and 8).

FIGURES 7 and 8: A lack of posterior support exacerbated the anterior tooth wear

He also planned to have dental implant treatment, at a later date, to address the lack of posterior support.

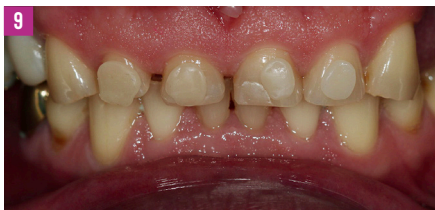
FIGURE 9: Small composite buttons using different shades of Venus Pearl composite were placed

Small composite buttons using different shades of Kulzer Venus Pearl composite were placed on the dry, unetched tooth surface and light-cured (Figure 9).

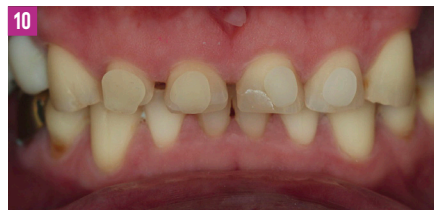
FIGURE 10: B1 shade was selected and verified with a polarised filter

B1 shade was selected by mutual agreement and verified with a polarised filter (Figure 10).

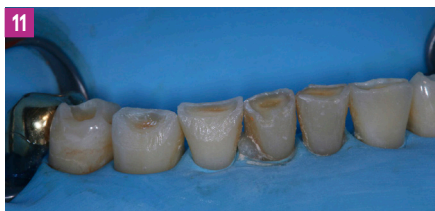
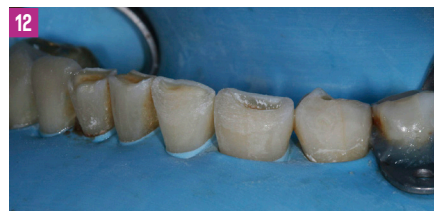
FIGURES 11 and 12: The lower anterior teeth were prepared lightly by bevelling the labial enamel and removing any sharp edges

The lower anterior teeth were prepared lightly by bevelling the labial enamel and removing any sharp edges (Figures 11 and 12).

The teeth were etched with 37% phosphoric acid gel, washed, dried and bonded. Kulzer Ibond Universal is my adhesive of choice due to ease of use, low viscosity and good dentine penetration. Ibond Universal provides a reliable bond strength because it contains the active ingredient 10-methacryloyloxydecyl dihydrogen phosphate (10-MDP).

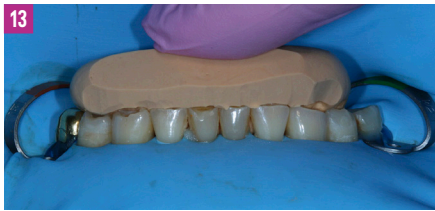
FIGURE 13: A silicone index was used to build the lingual surfaces

A silicone index was used to build the lingual surfaces with Venus Pearl B1 shade (Figure 13). The labial surfaces were placed using a freehand technique (Figures 14 and 15).

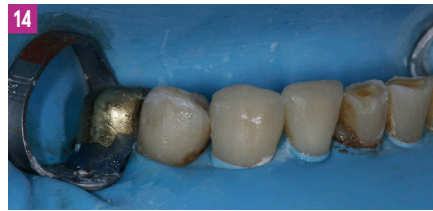
FIGURES 14 and 15: The labial surfaces were built using a freehand technique

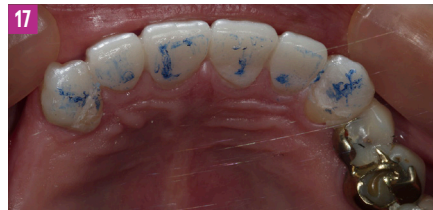
FIGURE 17: The occlusion was checked and adjusted

The shape and size of the anterior teeth were approved by the patient. Once the occlusion was checked and adjusted (Figure 17), a palatal

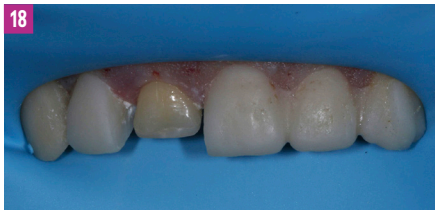
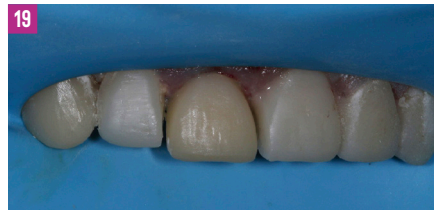
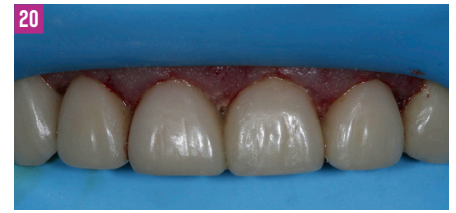
FIGURES 18, 19 and 20: For ease and predictable composite build-up, the acrylic shells were removed one by one

The labial surfaces were placed using a freehand technique. For ease and predictable composite build-up of the anterior teeth, the acrylic shells were removed one by one (Figures 18 to 20).

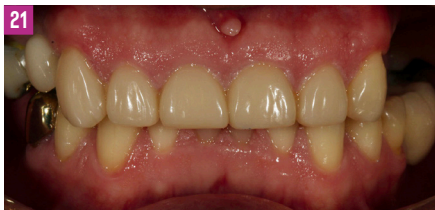
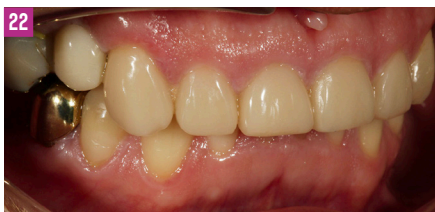
FIGURES 21, 22 and 23: Kulzer Signum liquid was used to sculpt and adapt the last layer of composite to the tooth surface

Kulzer Signum liquid is useful to sculpt and adapt the last layer of composite to the tooth surface using brushes (Figures 21 to 23).

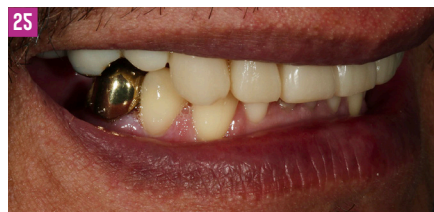
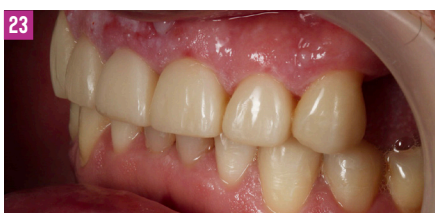
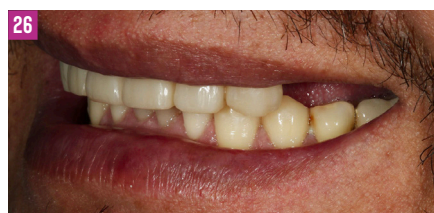
FIGURES 24, 25 and 26: The patient was very happy with the outcome and his confidence was restored

The patient was very happy with the outcome and his confidence was restored (Figures 24 to 26). The posterior teeth over-erupted into occlusion at the new increased occlusal vertical dimension after 12 months.
