To describe restoring a molar using a versatile and durable nano-hybrid composite. This article qualifies for one hour of enhanced CPD; answer the questions on page 100.

Allan Matthews describes restoring a molar using a versatile and durable nano-hybrid composite, which was endorsed by colleagues

Aesthetic and natural restoration

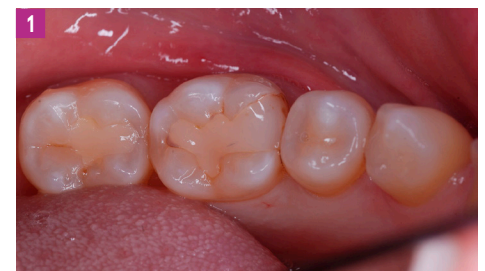
On presentation, one of the issues identified was a historic composite restoration in the lower left first molar, which had ditched margins and was beginning to stain and decay (Figure 1).

In addition, we found the old LL6 class II restoration to be an inaccurate shade and lacked anatomical character.

FIGURE 1: The patient presented with a historic LL6 restoration with ditched and stained margins

While the tooth was not exhibiting any symptoms, we elected to replace the failing restoration at an early stage rather than wait for progression and potential loss of further structure.

The treatment plan would be decided after deconstruction of the old filling and assessment of the remaining tooth structure.

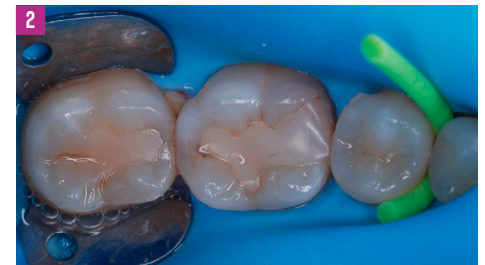
Isolation was achieved with rubber dam, which was placed with a clamp on the LL7 and stabilised with a latex cord between the premolars without causing obstruction of the working field (Figure 2). The existing restoration and the underlying caries were removed from the LL6 (Figure 3).

FIGURE 2: Rubber dam was placed with a clamp on the LL7 and stabilised with a latex cord between the premolars

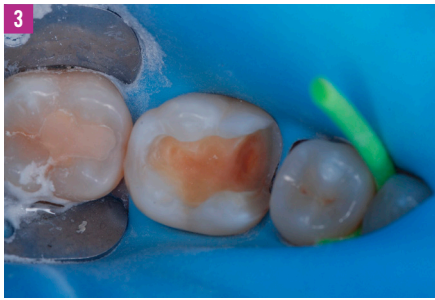
Air abrasion was carried out with 27-micron aluminium oxide to clean the surface and increase the bonding surface area.

No cracks were detected at this stage and the cusps were deemed to be of adequate thickness in the patient's existing occlusal scheme. Therefore, with the patient's agreement, we proceeded with the provision of a composite resin restoration.

FIGURE 3: The existing restoration and the underlying caries were removed

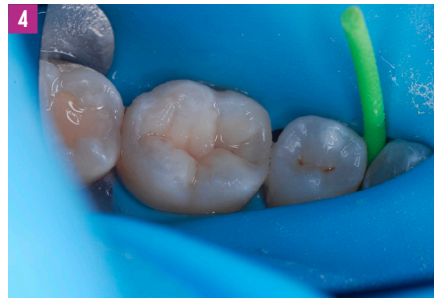
FIGURE 4: The chosen composite was Venus Diamond Flow, Venus Pearl Opaque Medium Chromatic (OMC) and A2 shade

A Bioclear sectional matrix was used for interproximal anatomical accuracy. The chosen composite was a combination of Kulzer Venus Diamond Flow, Kulzer Venus Pearl Opaque Medium Chromatic (OMC) dentine shade and A2 universal shade (Figure 4).

After application of a total-etch, two-component dental adhesive, a base layer of Venus Diamond Flow was placed, immediately followed by compression of Venus Pearl A2 shade to form the mesial wall with complete adaptation of the composite in the margins.

OMC shade was used to replicate the missing dentine and A2 was placed on top for recreation of the occlusal enamel layer.

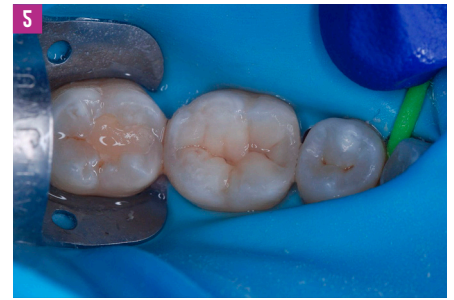
FIGURE 5: The incisal shade Amber (AM) was applied with an endodontic K-file

The incisal shade Amber (AM) was applied with an endodontic K-file into the anatomical fissures (Figure 5).

The amber resin was worked in with a microbrush before the use of a dry microbrush to soak up any excess. With characterisation such as this, less is always more!

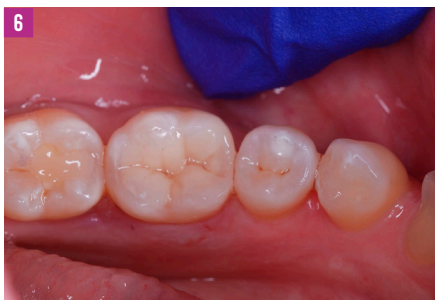
FIGURE 6: Rubber dam was removed, and the occlusion checked

Next, the rubber dam was removed, and the occlusion checked (Figure 6).

Careful adaptation of the fissures and inclines meant that there was little to no adjustment required in this case. Cusp and fossae contacts were maintained appropriate to the anatomy of the tooth.

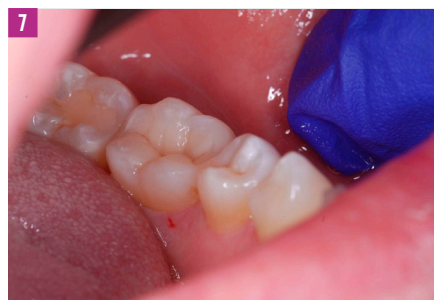
FIGURE 7: Successful integration, shade and anatomy match

Figure 7 shows an 'across-the-tooth' view and demonstrates the integration of the restoration into the surrounding structure. It revealed a

successful shade and anatomy match to the adjacent teeth.

There was a further improvement in integration once the teeth rehydrated 72 hours later.

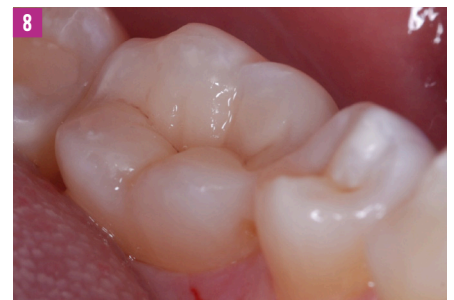
FIGURE 8: The patient was delighted with the natural-looking restoration

The patient was delighted with the natural-looking restoration (Figure 8). I also received positive feedback from fellow dentists after posting the case on social media.

While I feel the tooth anatomy could have been improved, I am pleased with how the composite has provided an aesthetic and integrated outcome.
