Straight to a confident smile

Jazz Battu describes a non-invasive composite restoration

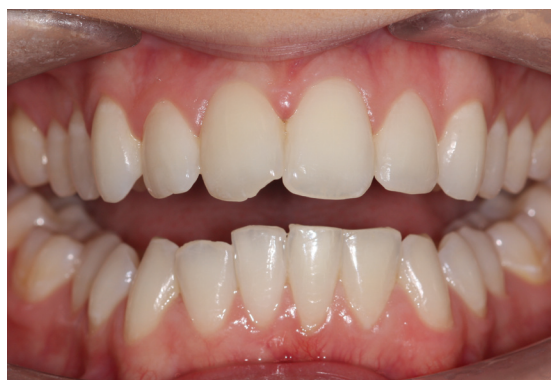
On examination, it was found that her upper right central incisor (UR1) was rotated and fractured, but her other teeth were in good alignment.

Figure 1: The upper right central incisor (UR1) was rotated and fractured

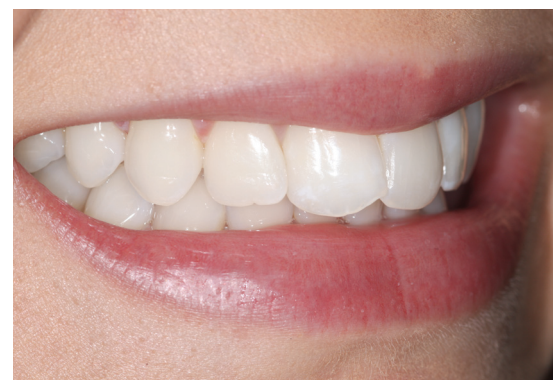
Figure 2: Lateral view of rotated UR1

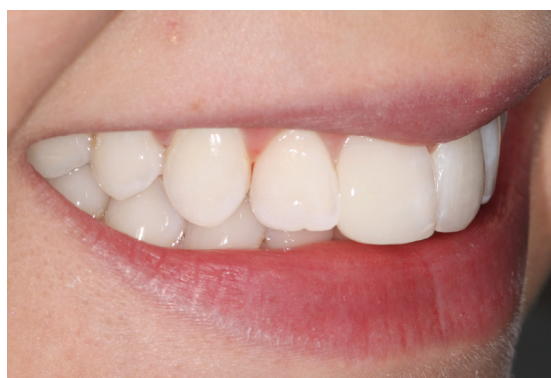
Figure 3: The distal face of the tooth was built up incrementally, using Venus Pearl B1 shade, to make the tooth appear straight

After placement of the rubber dam, the tooth was cleaned using a pumice preparation. Teflon tape was placed on the adjacent teeth to protect them from the etching and bonding agents. The distal face of the tooth was built up incrementally, using Venus Pearl B1 shade, to make it appear straight. The chipped mesial incisal edge was also restored.

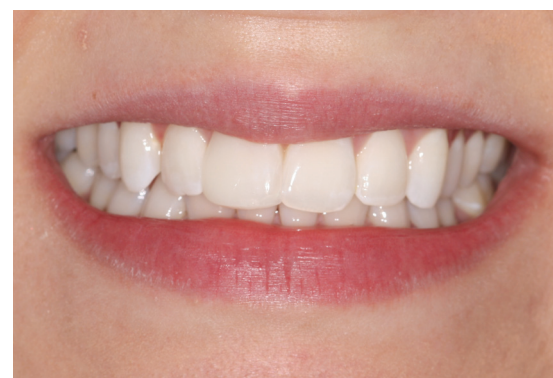
Figure 4: The patient was extremely pleased with the result and the non-invasive restoration provided

to achieve as close to the desired finish as possible. This limited the amount of reduction needed with handpieces, once the material had set. The restoration was completed with a diamond finishing kit and discs, and then buffed using Heraeus' Venus Supra composite polishing kit and a diamond paste.

I was very satisfied with the clinical outcome. The patient was extremely pleased with the result and the non-invasive restoration provided. She has since referred two friends to the practice for similar treatments. Another positive factor for the patient was the relatively low cost, compared to a porcelain veneer. **D**
